THE CHOICE OF INTERVENTIONS FOR STRENGTHENING OF HISTORICAL ADOBE STRUCTURES AND REMAINS IN BAM CITADEL "ARG-E BAM"

Dissertation

an der Fakultät Architektur
der
Technische Universität Dresden

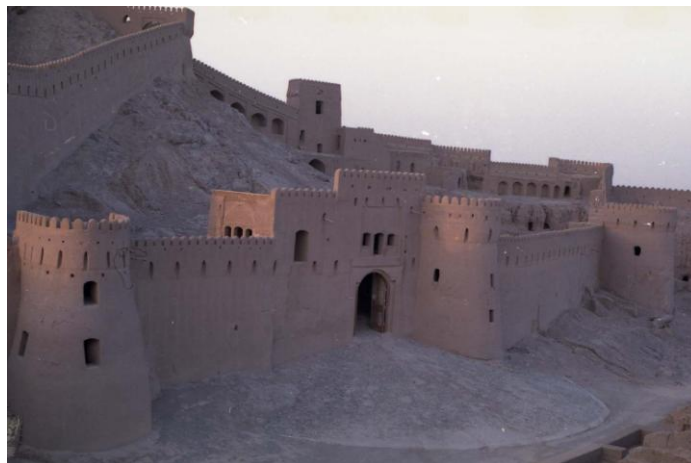
Generally there is not a designed foundation for most of the buildings in the Citadel, [44]. Traditionally the masons dug the ground and laid the adobe bricks like foundation cores. They used the natural base of the ground for this purpose. Obviously because of the heavy weight of the adobe building, an initial settlement happened and the soil under this base was consolidated under the pressure. Two kinds of bed soil could be seen in the Citadel: Rock bed base, Figure 24 and consolidated bed base, Figure 25. The first one is mostly found in the north parts, the Governor's Seat.

Figure 24 Foundation of the Second Walls, the bed is from rock and stone

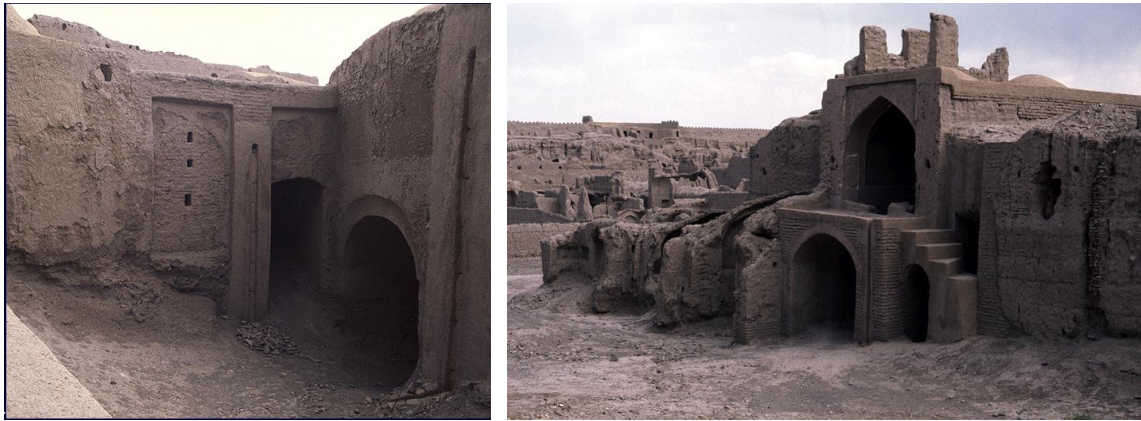
Figure 25 Consolidated foundation of the Caravansary, the bed is from compacted soil and the natural ground

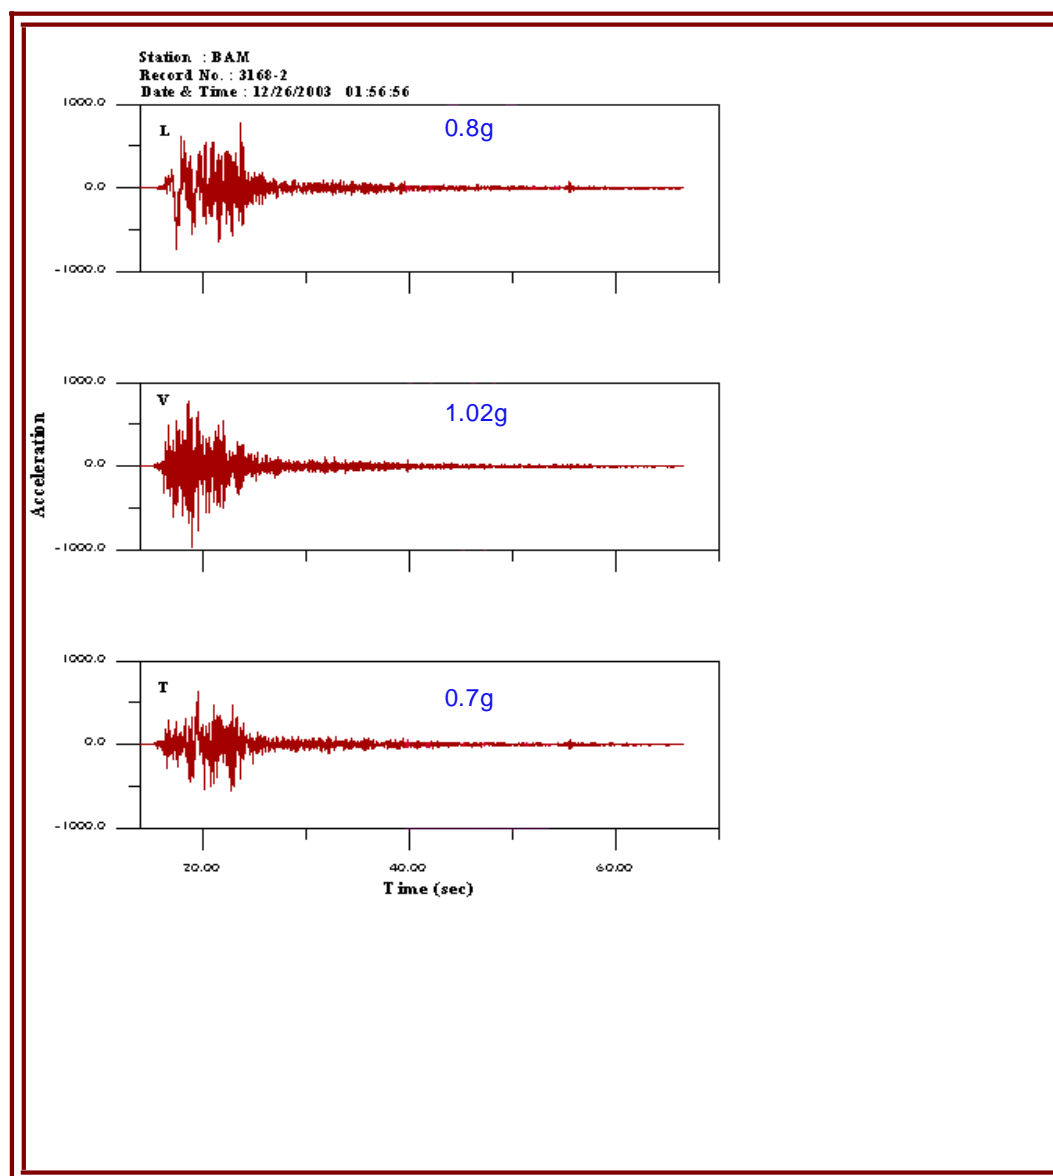
Figure 34 The accelerographs for the main shock recorded in Bam station, [15]

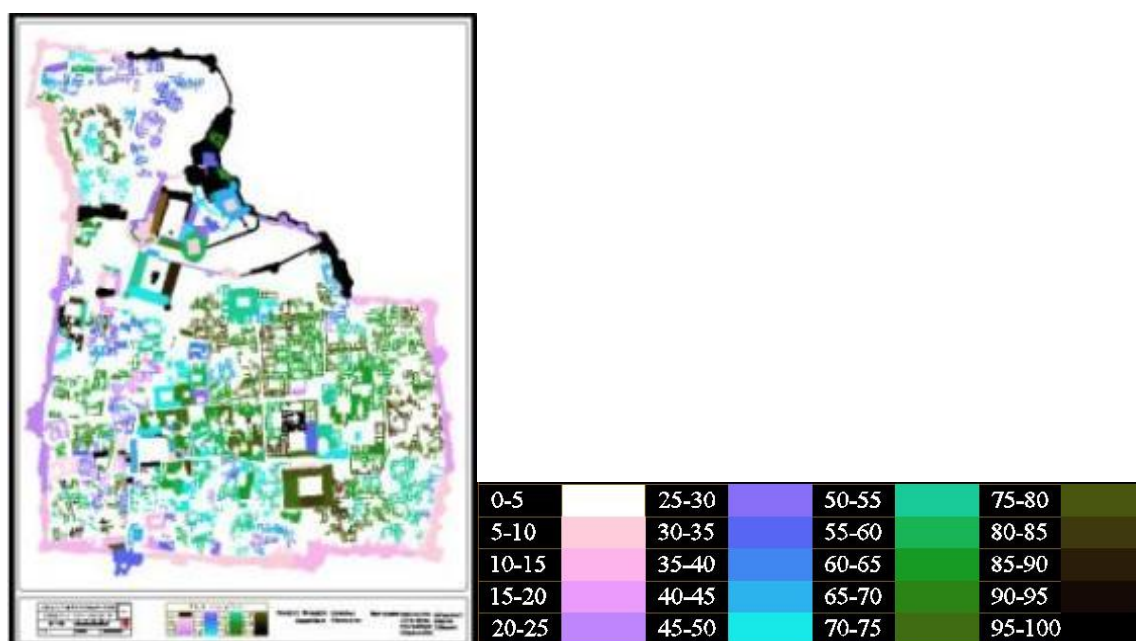
Figure 36 Demolition percentage in Bam Citadel, by Keramatfar (2005)

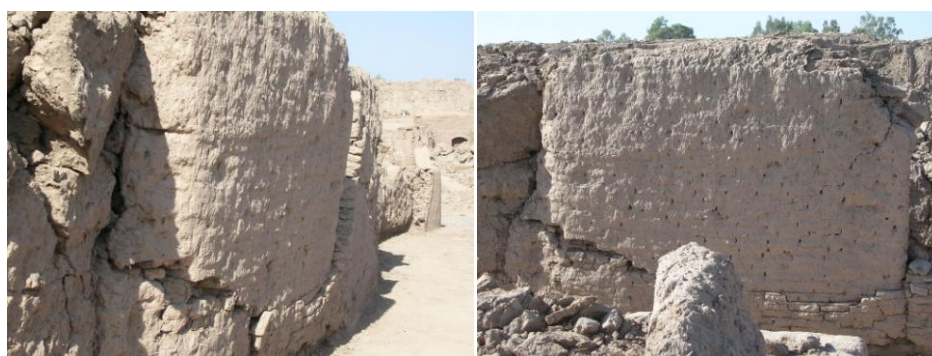
Figure 37 Horizontal and diagonal cracks after Earthquake, 2003.

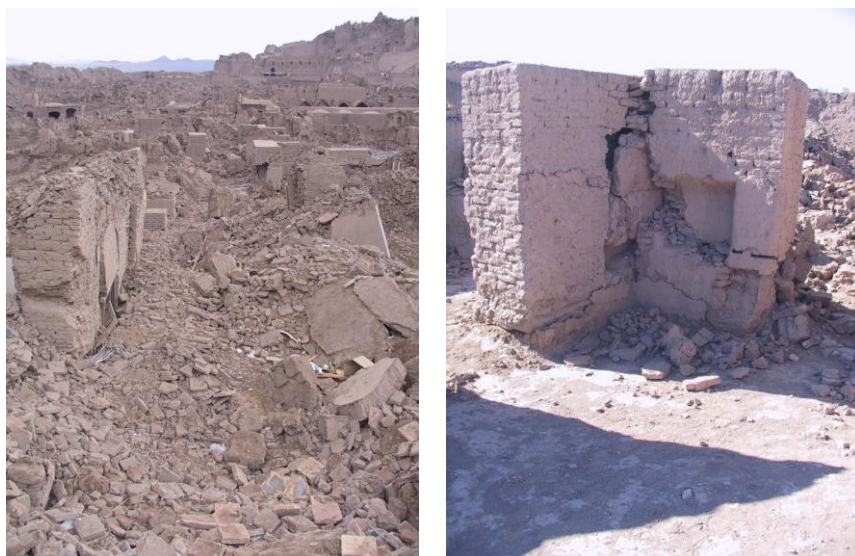
Figure 38 Cracks, crashing and collapse after Bam Earthquake, 2003

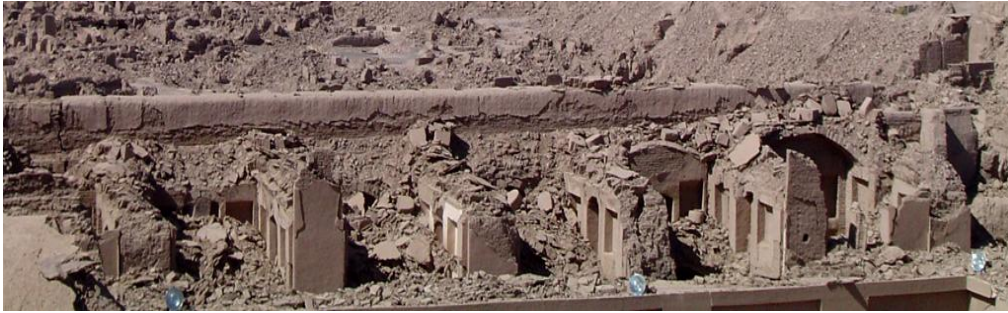
- Wall thickness and the slenderness ratio
- The connection between the walls and the roof or floor system
- Whether the wall is load-bearing or non-load-bearing
- The distance between intersecting walls
- The condition of the base of the wall

Figure 40 Out of plane walls, remain following the earthquake in 2003.

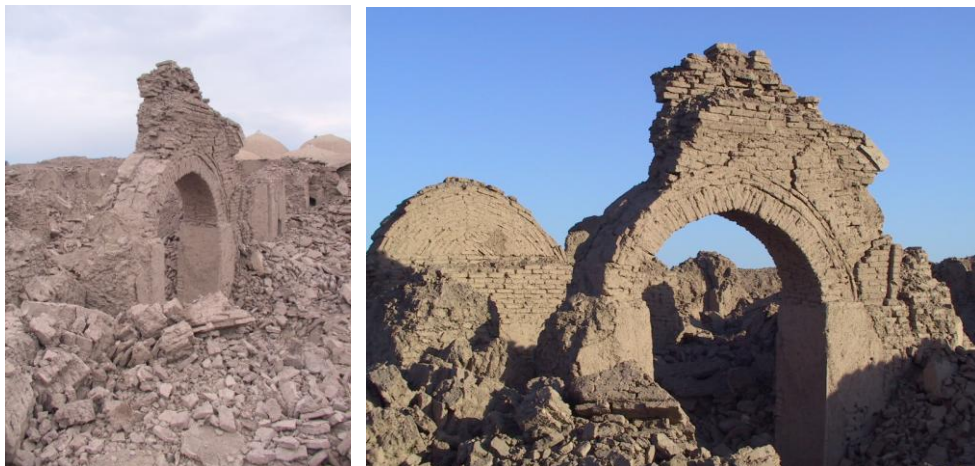
The severity of in-plane cracks is judged by the extent of the permanent displacement that occurs between the adjacent wall sections or blocks after ground shaking ends (Figure 41). More severe damage to the body with a vertical displacement, that is, when the crack pattern follows a more direct diagonal line and doesn't "stair-step" along mortar joints. Diagonal shear cracks can cause extensive damage during prolonged ground motions because gravity is constantly working in combination with earthquake forced to exacerbate the damage.

Figure 41 In-plane cracks, after the earthquake in 2003

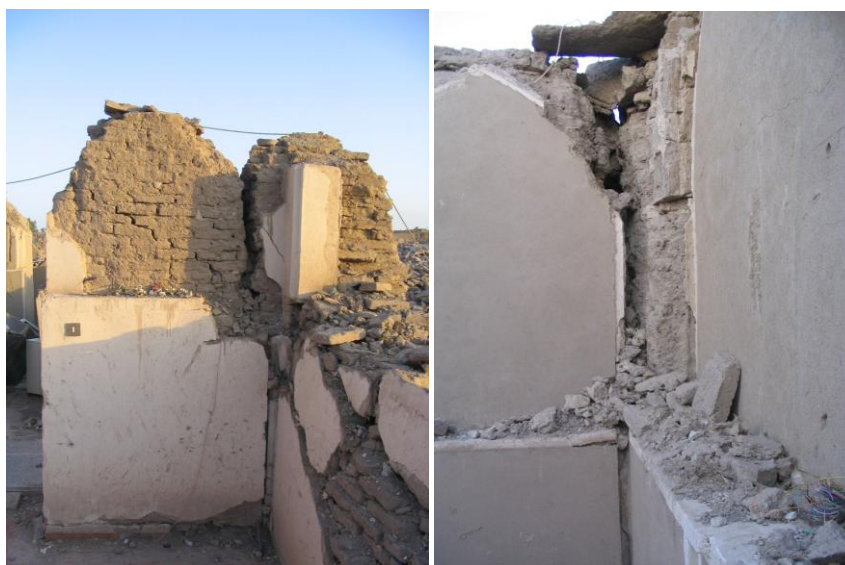
These kinds of damages happen at the corner of buildings due to the stress concentrations that occur at the intersection of perpendicular walls. Instability of corner sections often occur because the two walls at the corner are unrestrained and therefore the corner section is free to collapse outward and away from the building. Vertical cracks at corners: vertical cracks often develop at corners during the interaction of perpendicular walls (Figure 42) and are caused by flexure and tension due to out-of-plane movements. This type of damage can be particularly severe when vertical cracks occur on both faces, allowing collapse of the wall section at the corner. Diagonal cracks at the corners: In-plane shear forces cause diagonal cracks that start at the top of the wall and extend downward to the corner. This type of crack results in a wall section that can move laterally and downward during extended ground motions. Damage of this type is difficult to repair and may require reconstruction.

Figure 42 Cracks in the corner

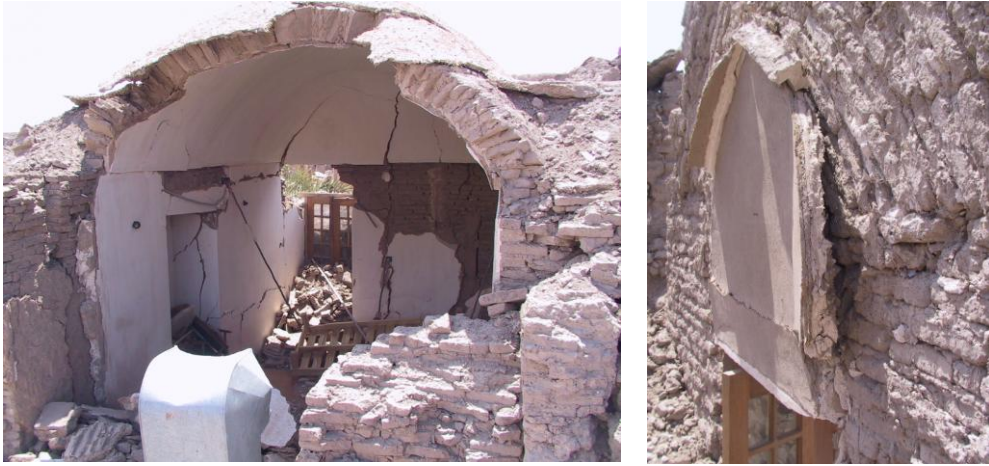
Cracks start at the top or bottom corners of openings and extend diagonally or vertically to the tops of the walls. Cracks at openings are not necessarily indicative of severe damage. Wall sections on either side of openings usually prevent these cracks from developing into large offsets. However, in some cases, these cracks result in small cracked wall sections over the openings that can become dislodged and could represent a life-safety hazard.

Figure 43 Cracks and crash at openings

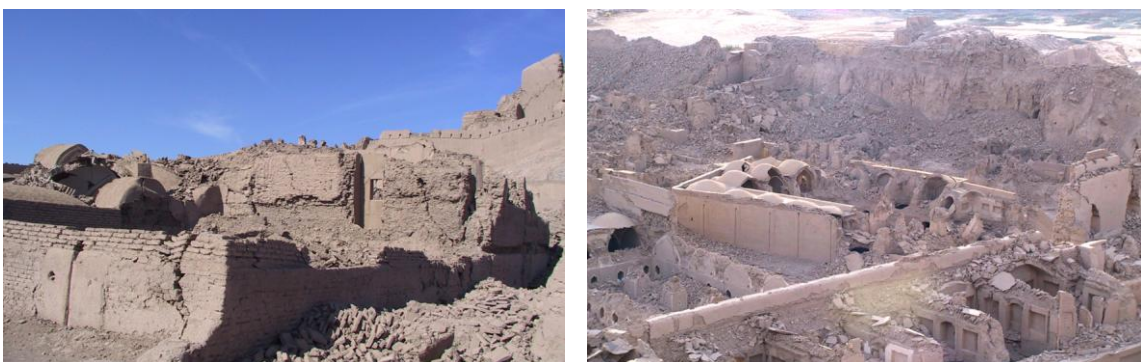
serious from a life-safety perspective. However, in the same way that corner damage occurs, adjusted walls can become isolated and behave as freestanding walls. When they reach this state, the possibility of collapse or overturning is greatly increased, and a serious life safety threat can arise. In addition, if significant permanent offsets occur, repair may be difficult and expensive.

Figure 44 Cracks and collapse at intersections

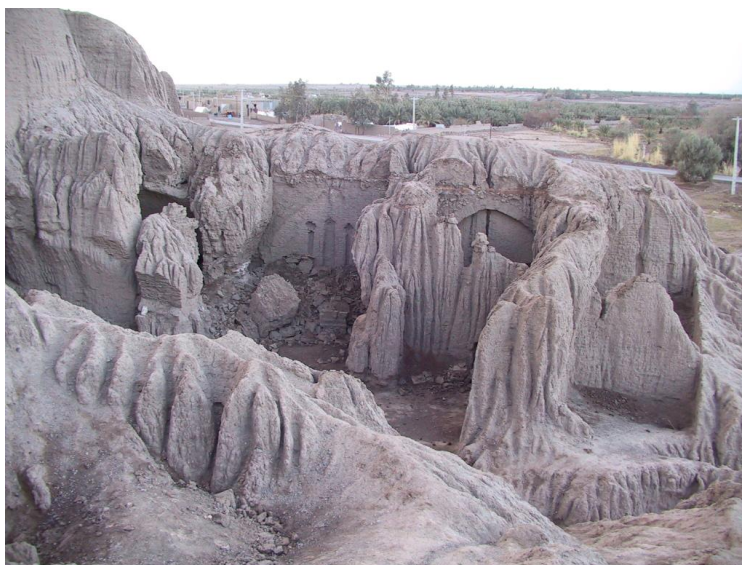
The major difference between the behaviour of adobe and that of the other masonry materials, such as brick or stone, is the dramatic reduction in strength when adobe becomes wet. Brick and stone can become saturated and still retain a large proportion of their strength, whereas long before adobe has reached saturation, its compressive and tensile strengths may have been reduced from 50% to 90%, Keramatfar (2005). This reduction in load-carrying ability can result in material that can fall even under normal loads.

Figure 45 Erosion in adobe structure and remains

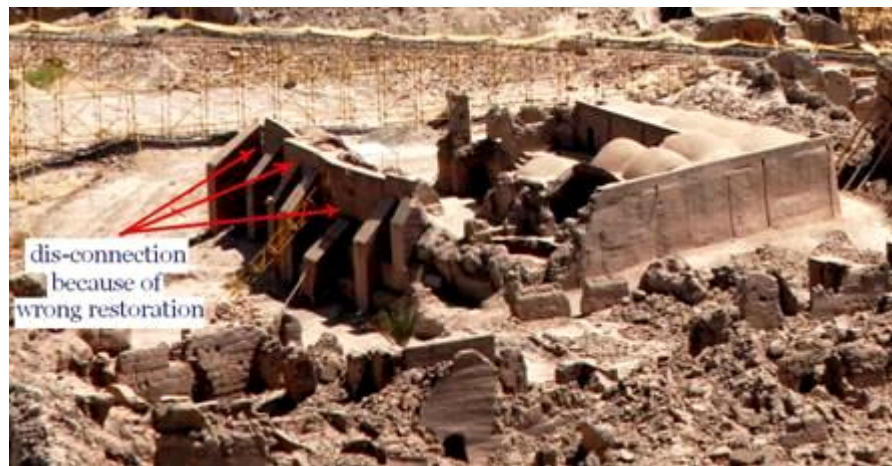
Figure 50 Collapse because of neglect of the engineering calculation for the buttress, [53]

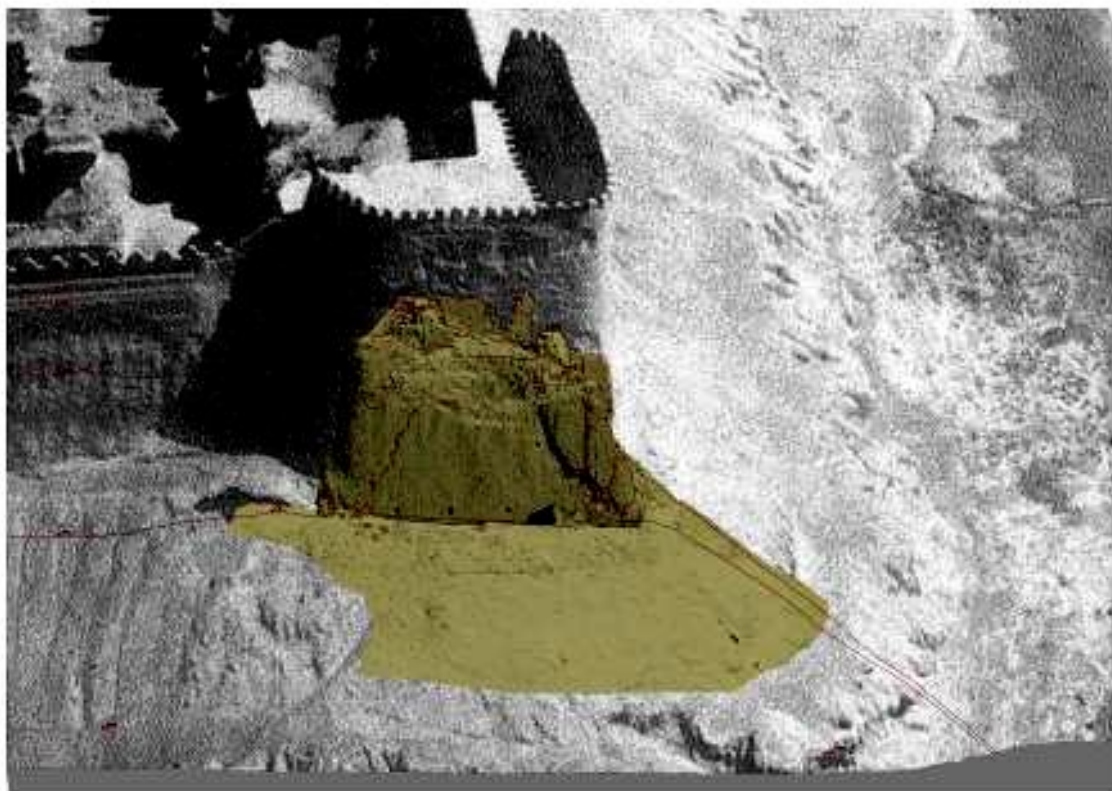
Figure 69 About 20% of Tower No. 1 was destroyed, [39] and [37]

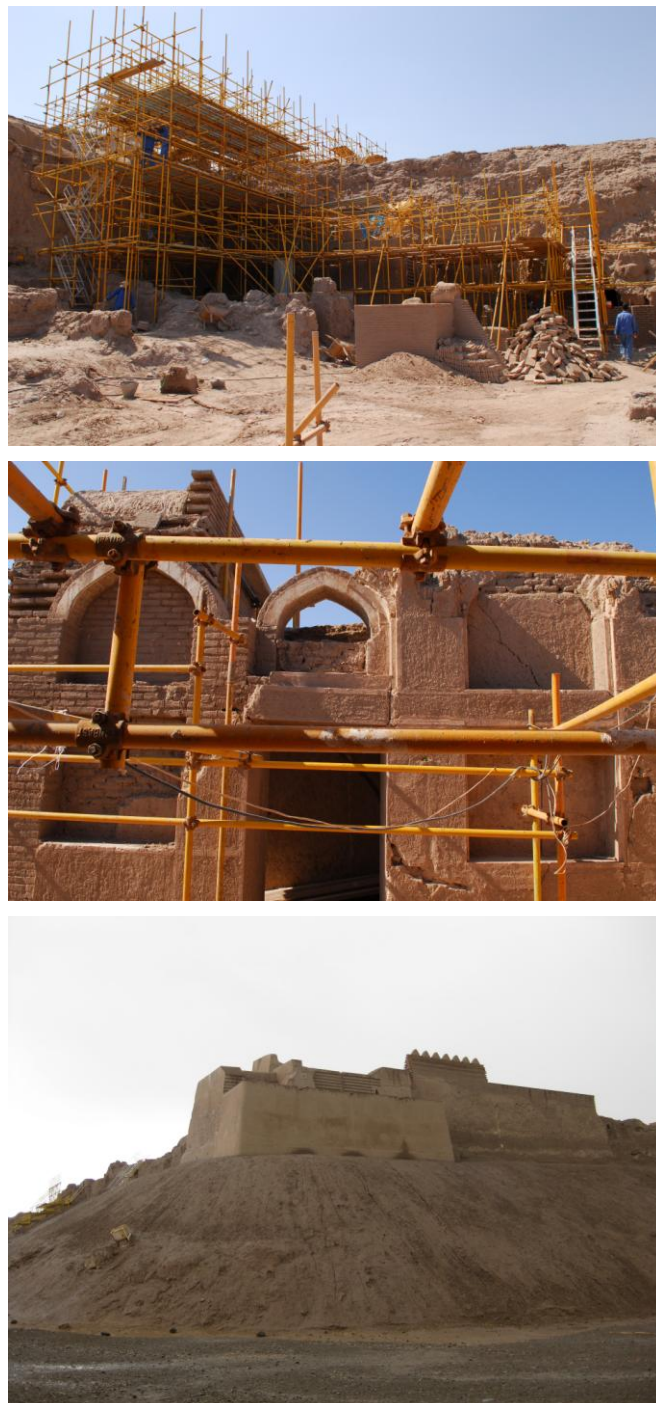
Figure 71 Restoration work for Tower No. 1

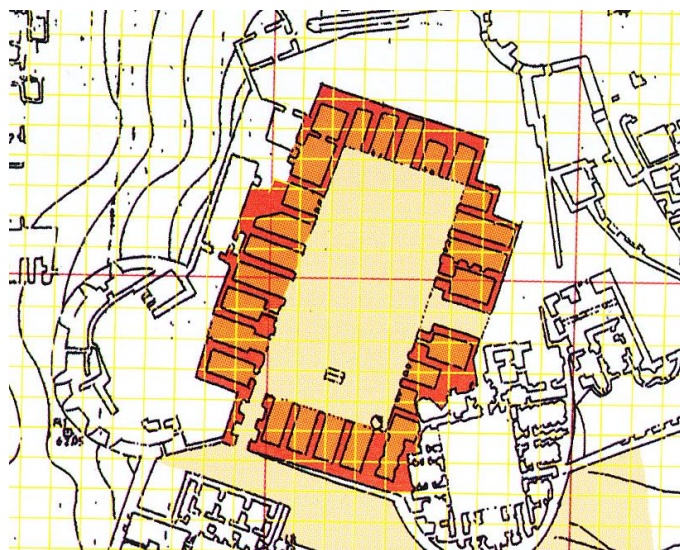
Figure 79 The eastern part of Barracks has been destroyed more than 95%. It is that part which has collapsed during the earthquake in 2003, [39].

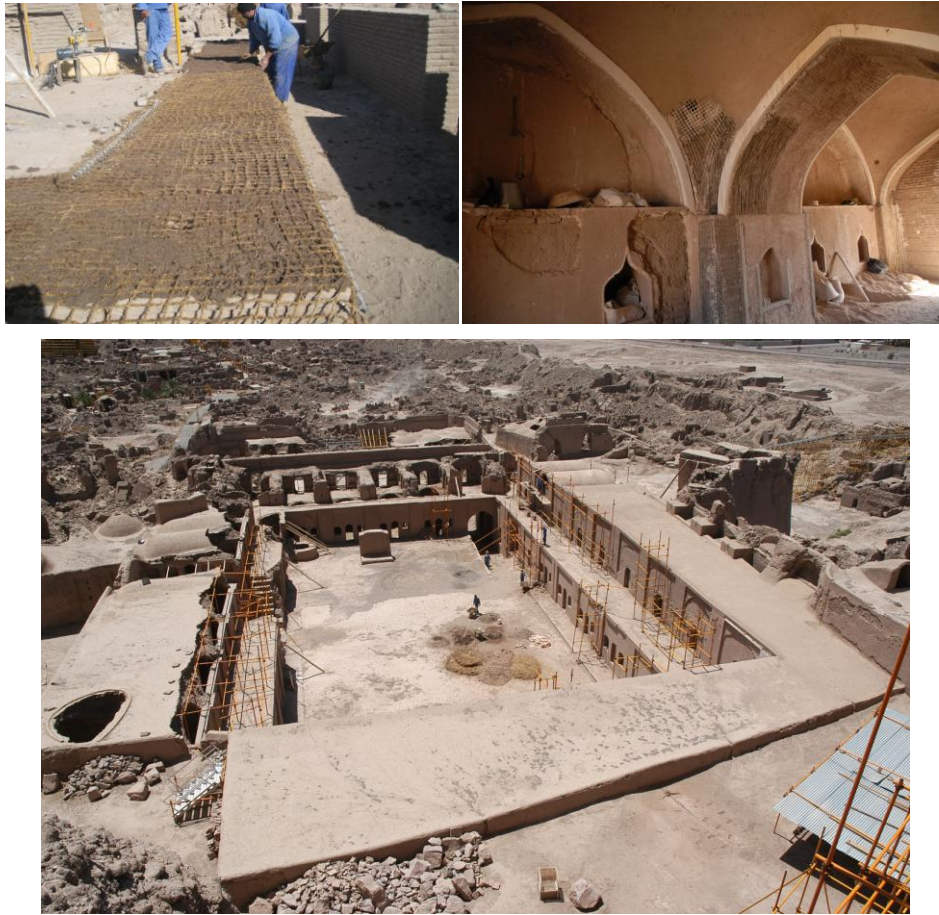
Figure 83 Applying meshes in Small Storage, Stable, and lightening in Barracks
